Waste foundry sand. Environmental implication and characterization

Gabriela Penkaitis¹ and Joel Barbujianni Sígolo¹

¹Department of Sedimentary and Environmental Geology, Institute of Geosciences, Universidade de São Paulo - USP, Rua do Lago 562, CEP: 05508-080, São Paulo, SP, BR (gabrielap@usp.br, jbsigolo@usp.br)

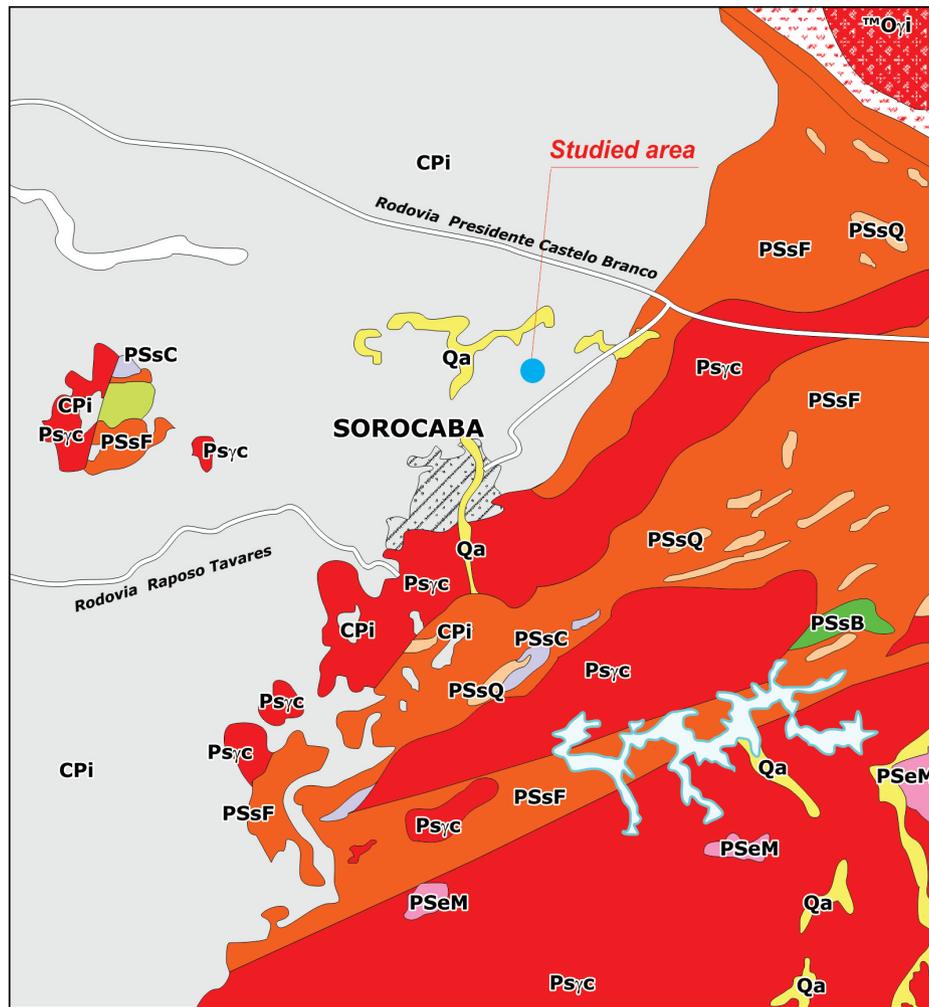
Figure 1. Geological map of the region of Sorocaba and location of study area.

The Sorocaba city is precisely located in the limit between the sediments of the sedimentary Paraná Basin and the rocks of the crystalline basement. The city is situated among the rocks of the Itararé Supergroup. Younger sedimentary deposits overlay this unit and are composed of alluvial deposits, sands and clays, and conglomerates in the base, occurring mainly along the main drainage channels and in the north part of the city, along the Sorocaba river. Figure 1 shows the geological map of the region and the localization of the study area.

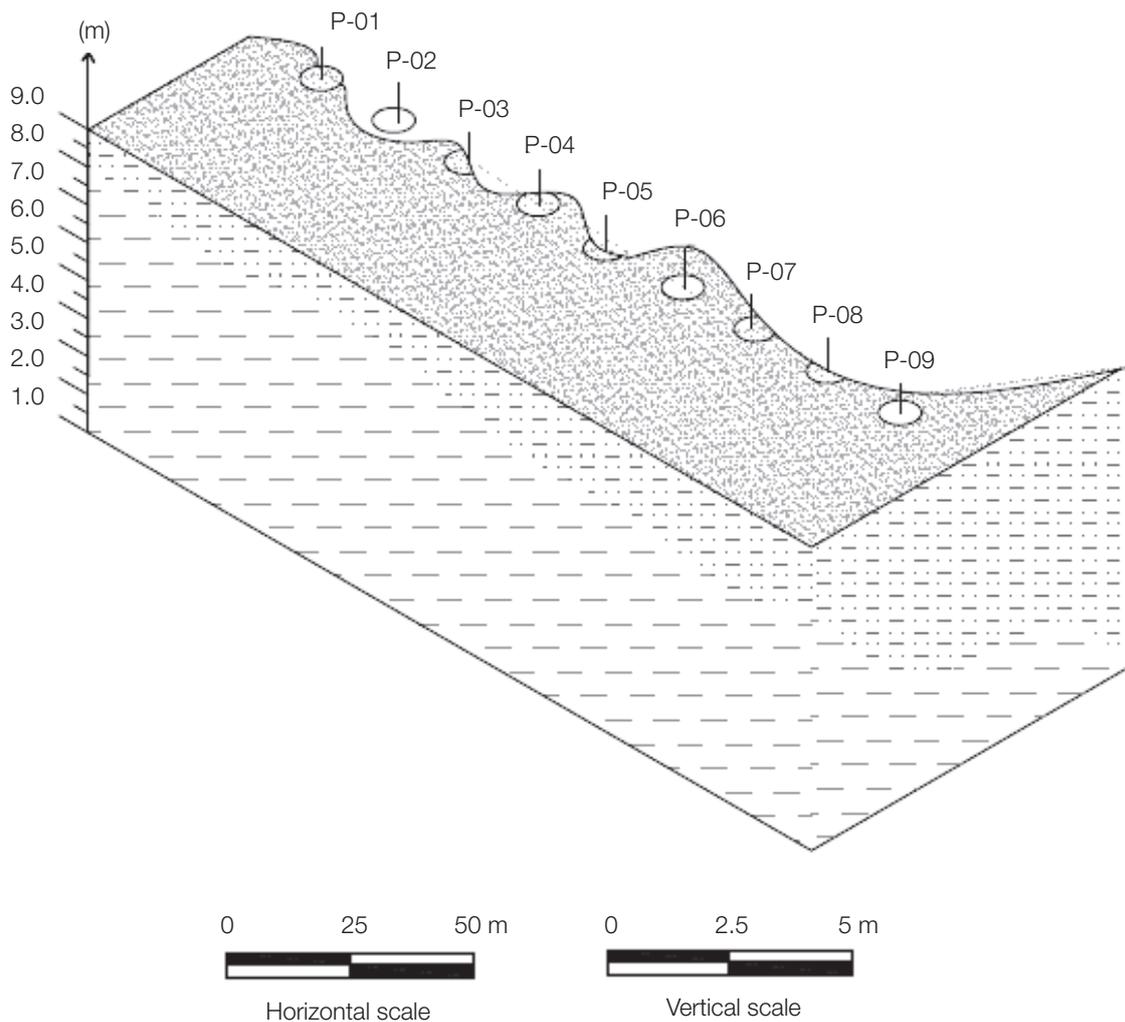
Figure 2. Profile of waste sample collection – Group A.

- Group A: Samples collected up to 20 cm deep in nine locations, 30 m apart from each other, totalizing the 270 m of width of the body (nine samples). Approximately 30 kg of samples were collected in each location. Figure 2 shows the sampling profile of Group A, and Figures 3 and 4 illustrate part of the excavation sites of this group.

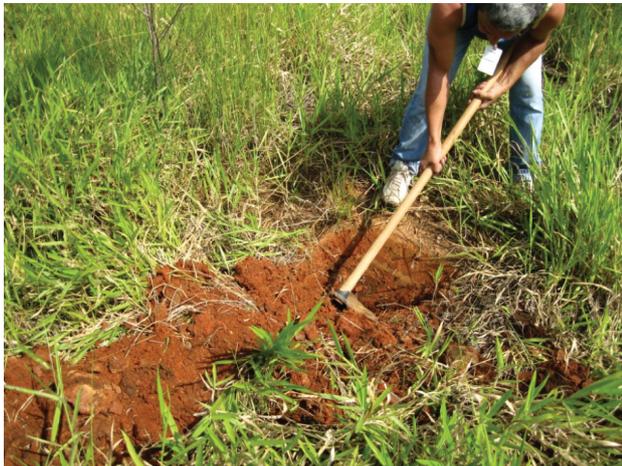
Figure 3. Excavation for collection of waste sample (Group A).

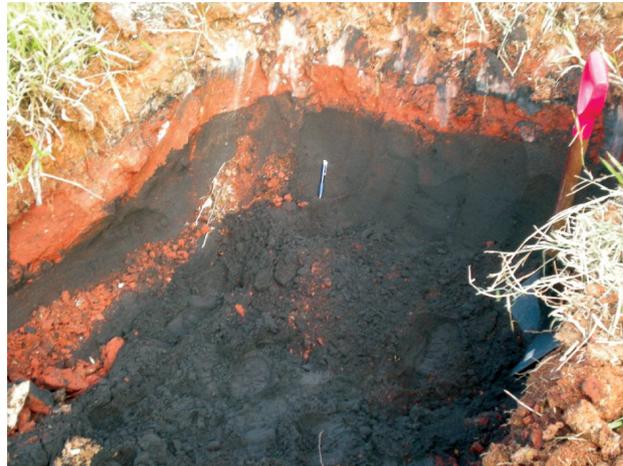
Figure 4. Depth of the waste collected (Group A).

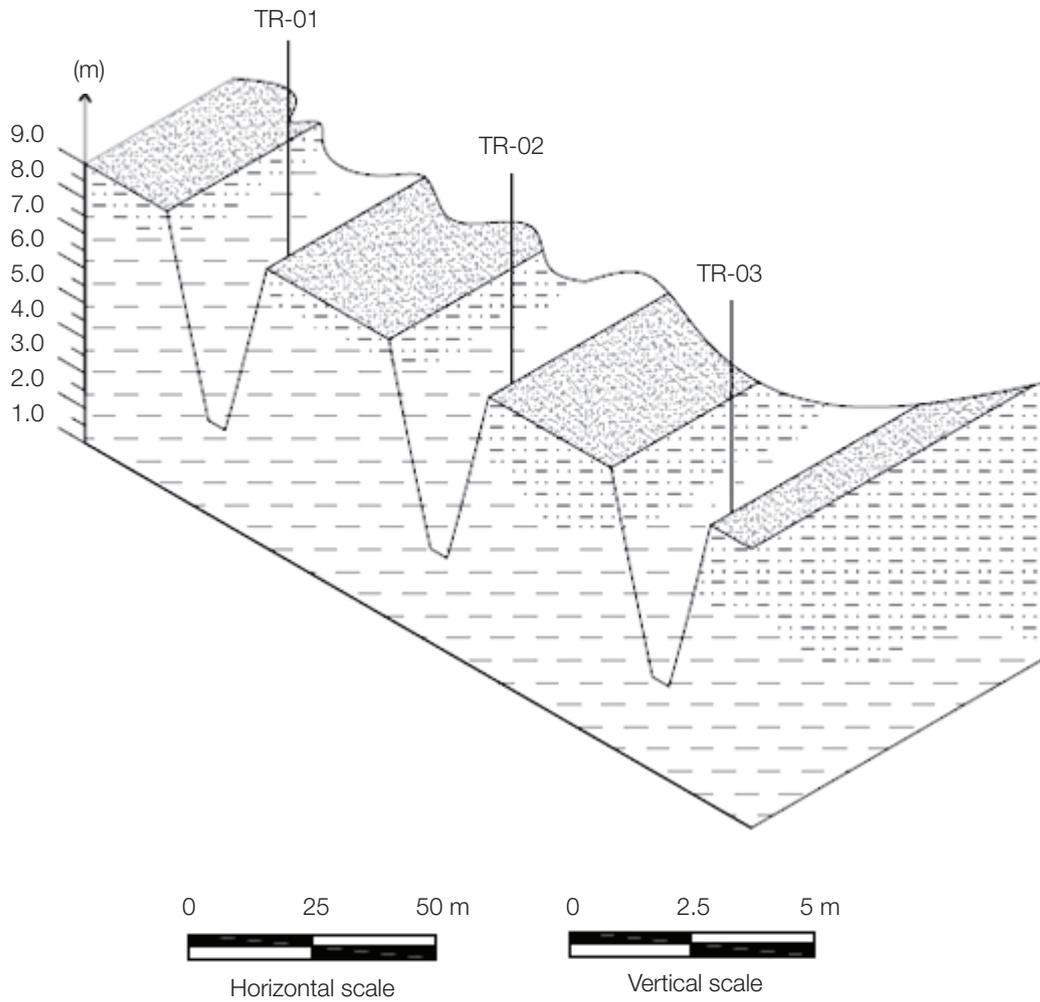
Figure 5. Profile of waste sample collection – Group B.

- Group B: Three trenches were excavated using a backhoe in the disposal area for collecting waste samples (TR-1, TR-2 and TR-3). The size and depth of the body were considered to define the excavation sites. The approximately 6.5 m deep trenches were excavated 90 m apart from each other, and 100 kg of waste were collected in the resulting pile. Figure 5 shows the sampling profile of Group B, and Figures 6 and 7 illustrate part of trenches opened for collecting Group B samples.

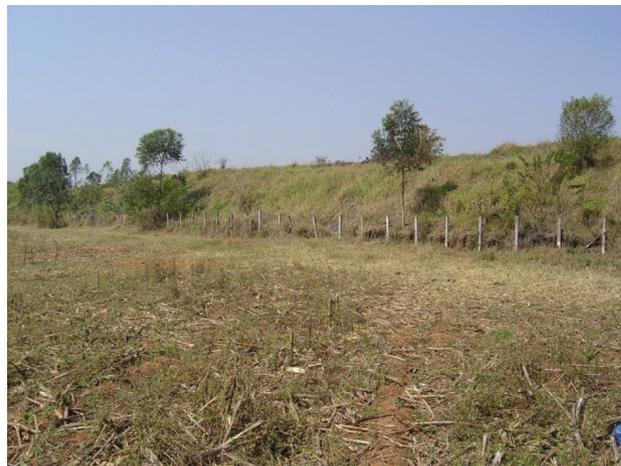
Figure 8. Waste disposal area.

The results indicate that the volume of the waste body is 272,160 m³ (270 m length, 120 m width and approximately 8.4 m height). Considering that its density is 1.8 g/cm³, it is inferred that 490 thousand tons of waste foundry sand have been deposited during approximately 35 years of operation, as shown in Figure 8.

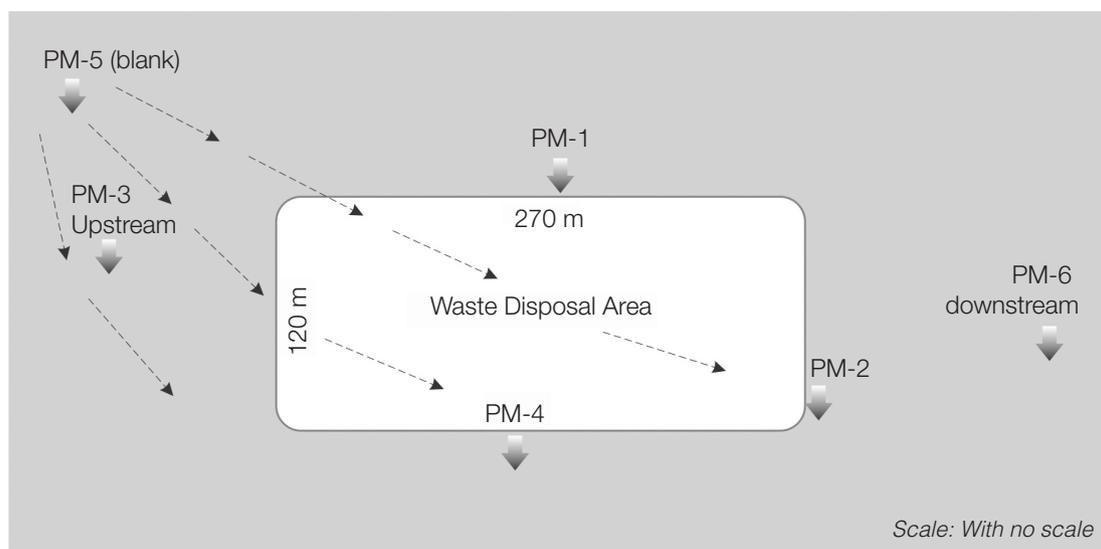
Figure 9. Location of monitoring wells and flow of groundwater.

The groundwater flow was determined, according to the USEPA guidelines (1994), using an electrical measurer, which measures the water level (WL) in each well after stabilization. Monitoring well location and groundwater flow are shown in Figure 9.

Most elements, many of them above the limits established by the regulatory bodies, were detected in wells 1, 2 and 4, which are located in the foundry sand disposal area, as shown in Figure 9. Comparing the upstream well (PM-3) with the downstream well (PM-6), the results show higher concentration of elements in the well located downstream of the landfill. Even if only iron, manganese, boron and selenium are above the legal limits, the increase in the concentration of other elements indicates that the foundry sand disposal causes environmental impact in the area.

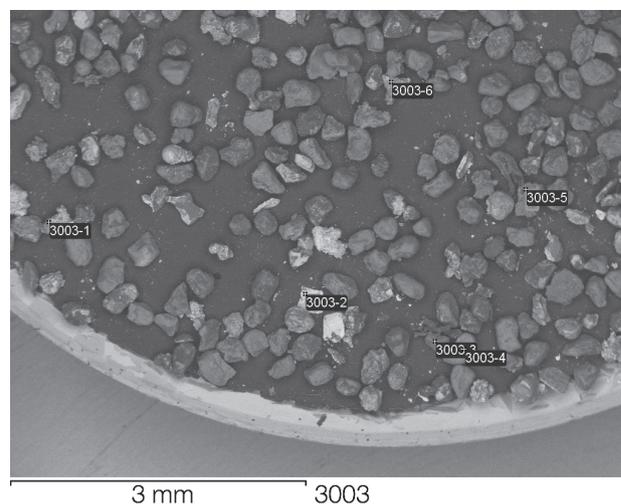
Figure 10. Scanning electron microscopy image with magnification of 50X of sample IV-A.

SEM images and spectrograms obtained from qualitative chemical analysis of some samples of Group A are

shown in Figures 10 to 12, and images and spectra of some samples of Group B are shown in Figures 13 to 15. Concerning the mineralogy, the presence of rounded grains with specific morphology indicate a silicatic composition, probably quartz, as shown in the spectrograms, many times with incrustations, which are formed during the production of alloys in the foundry. Metals, such as silicium, manganese, zinc, chromium, iron and magnesium, are observed in both groups, and the presence of

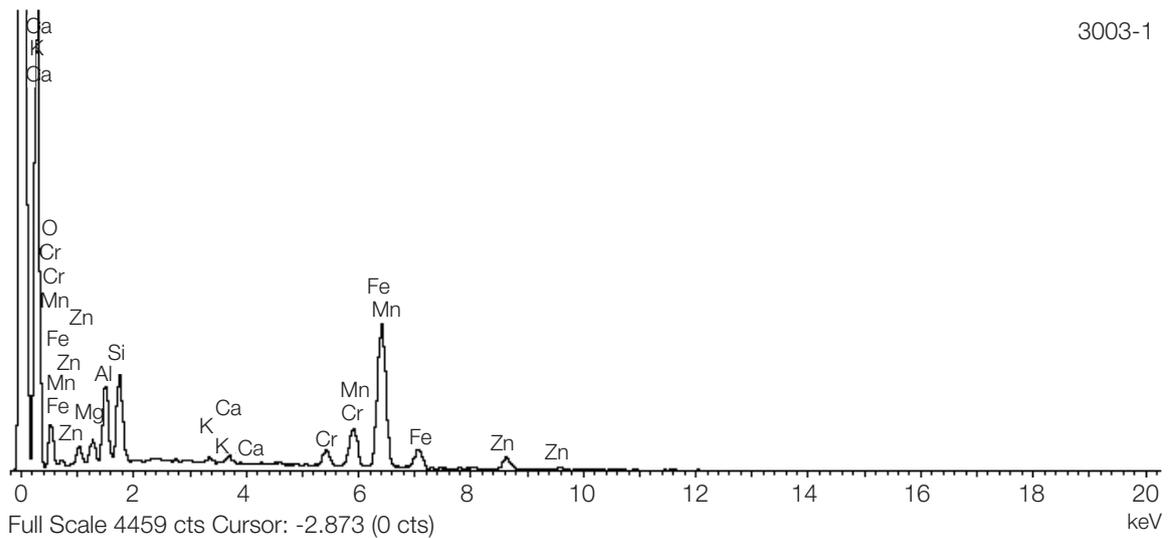
Figure 11. Energy dispersive x-ray spectrometer spectra of sample IV-A: the peak of calcium stands out, following by the iron, manganese, chromium and zinc peaks.

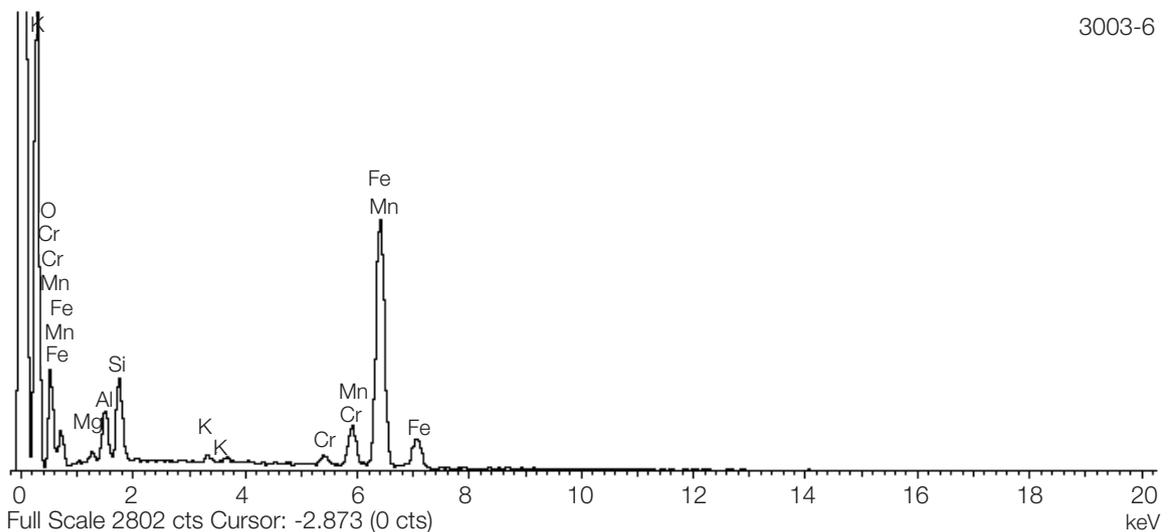
Figure 12. Energy dispersive x-ray spectrometer spectra of sample IV-A: the peak of K stands out, following by the iron, manganese, silicon and chromium peaks.

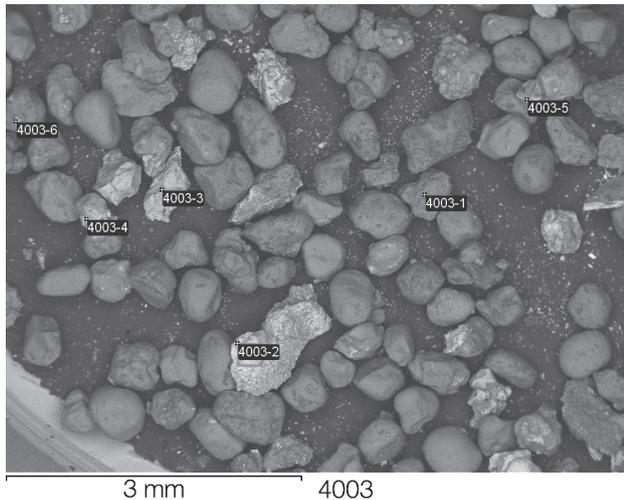
Figure 13. Energy dispersive x-ray spectrometer image with magnification of 50X of sample II-B.

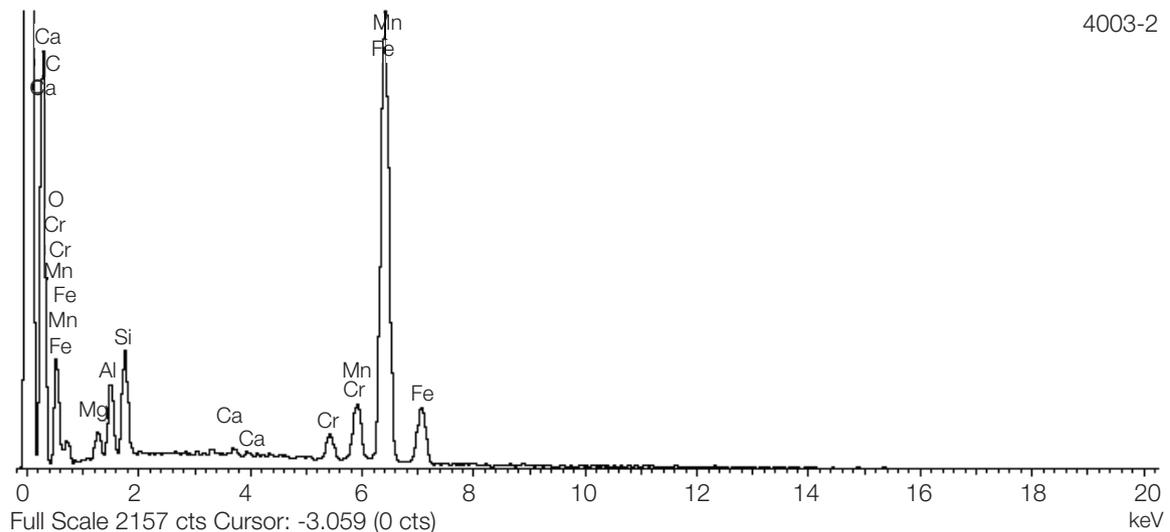
Figure 14. Energy dispersive x-ray spectrometer spectra of sample II-B: the peak of calcium stands out, followed by the iron, manganese and chromium peaks.

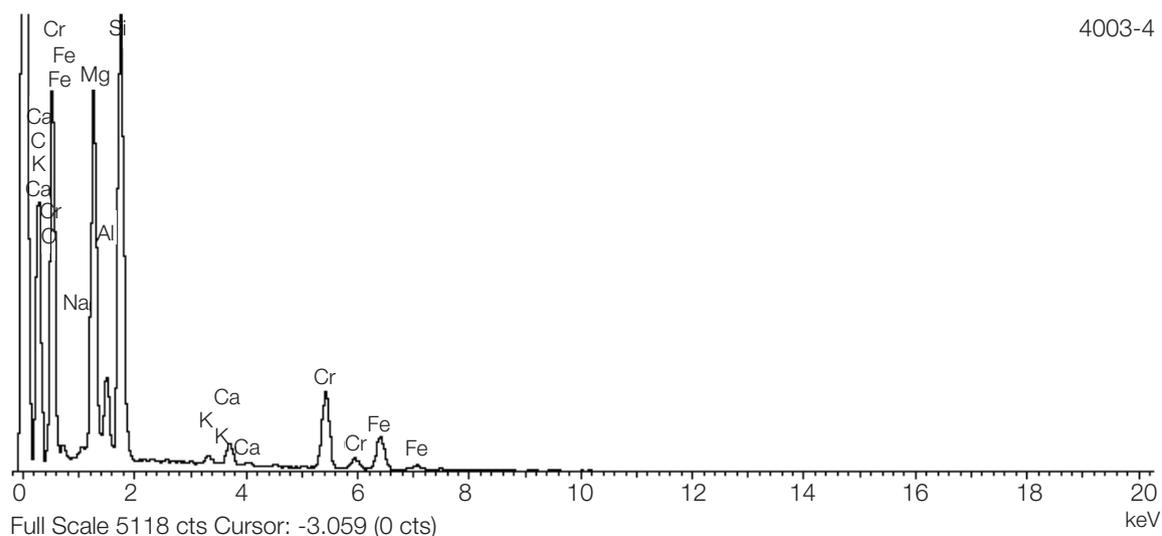
Figure 15. Energy dispersive x-ray spectrometerspectra of sample II-B: the peak of silicon stands out, followed by the iron, chromium, calcium, aluminum and potassium peaks.
