Erosion vulnerability and risk on Amazon estuarine beaches (Marajó Island, Brazil)

As the coastal zone is dynamic and subject to change from both natural and anthropogenic drivers, coastal vulnerability assessment is an essential tool for marine spatial planning, adaptation and mitigation of impacts. The eastern coastal environments of Marajó Island, the largest river-estuarine island in the world, are partially anthropized and vulnerable to erosion due to global (changes in sea level) and local (high-energy conditions on a tide-dominated coast) processes. It hosts diverse traditional communities which rely on the ecosystem services provided by the coast, as well as growing touristic activity and urbanization on the east coast. Here, vulnerability to erosion (Low: 0 to 5; Moderate: 6 to 10; High: 11 to 16) and risk level was assessed on two distinct estuarine beaches on the eastern coast of Marajó Island: Praia Grande and Barra Velha. A semi-quantitative analysis considered human occupation and natural parameters using remote sensing and *in situ* data collection techniques. Results indicated that Barra Velha beach has moderate vulnerability to erosion (value 10) in the northweste

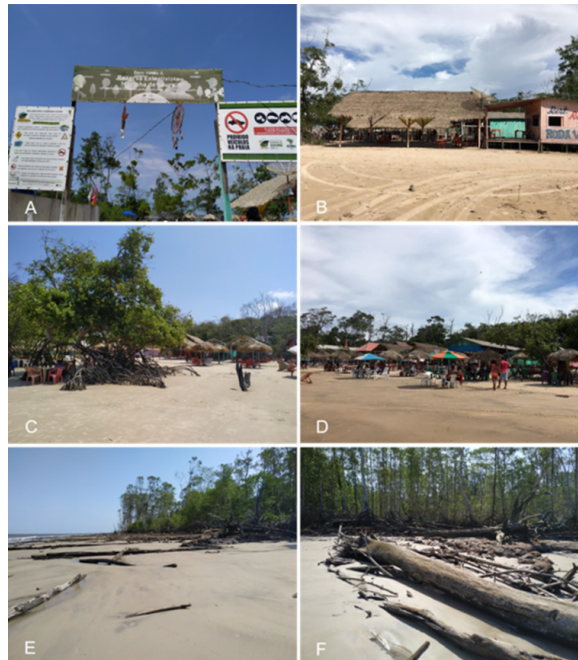
Figure 2. Artificial structures (A, B, C, and D) in the northwestern sector and natural protective structures in the southeastern sector (E and F) of Barra Velha beach. Photographs taken 05/02/2021 (B and D) and 09/14/2019 (A, C, E, F)

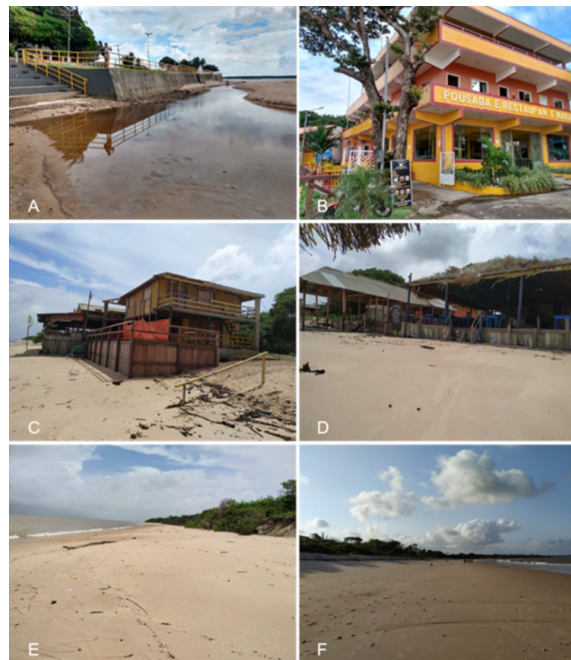
Figure 3. Artificial structures (A, B, C, and D) in the northwestern sector and natural protective structures in the southeastern sector (E and F) on Praia Grande beach. Photographs taken 05/02/2021 (A and B) and 9/13/2019 (C-F)

been replaced by hard structures (seawalls) to counter erosion (Figure 3a). Small dune scarps

were observed in the southeastern sector (Figure 3e and 3f).

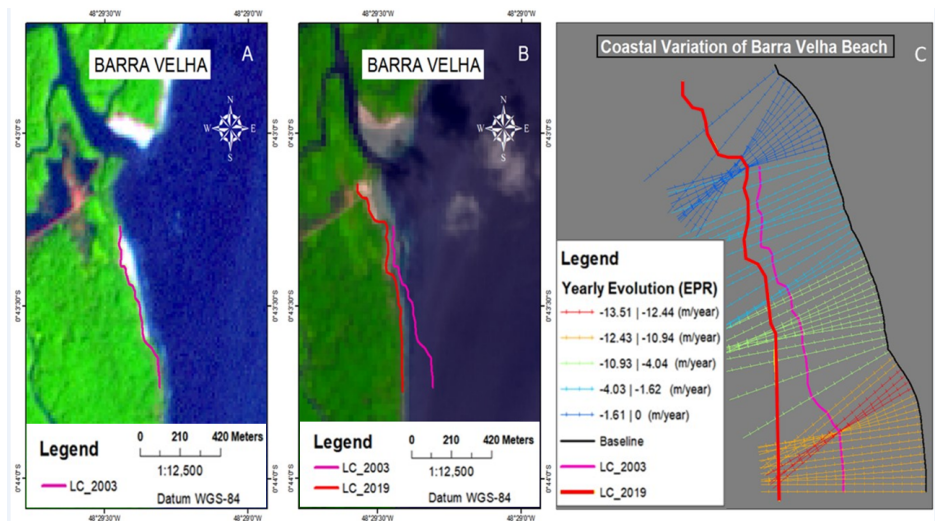
Figure 6. Shorelines of Barra Velha Beach in 2003 and 2019. Landsat 7/ETM image of 2003 (A) and Landsat 8/OLI image of 2019 (B). Annual shoreline development rates measured by End Point Rate (EPR) between 2003 and 2019 (C)

Over the study period (16 years), the mean spatial amplitude was -81.34 m, and only Barra Velha retreated, which indicates an erosive tendency on the coast (Figure 6). Mean linear variation in the northwestern sector was -18.81 m, well below the mean linear variation in the southeastern sector (-150.2 m). EPR results show a mean beach variation rate of -9.93 m/year, with -3.15 m/year in the northwestern and -9.58 m/year in the southeastern sector (Figure 6).

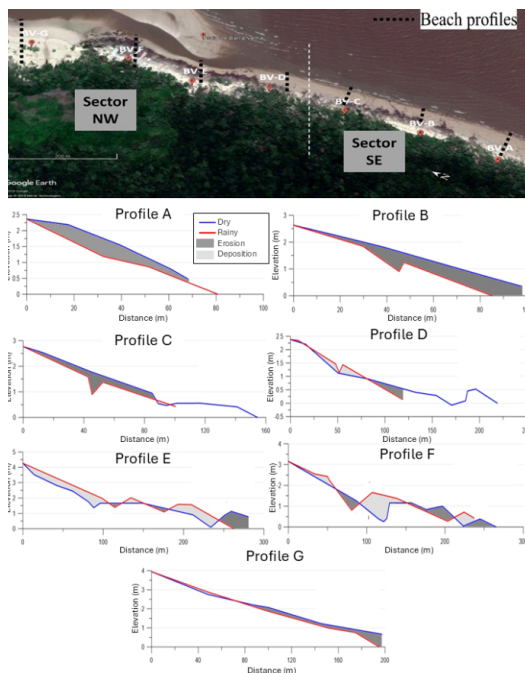
Figure 8. Beach profiles of Barra Velha, adapted from Souza and Ranieri (2023). Photographs taken on 9/14/2019 (dry season) and 2/13/2020 (rainy season)

half of the topographic profiles, whereas erosion occurred in the other half (Figure 8; Table 4).

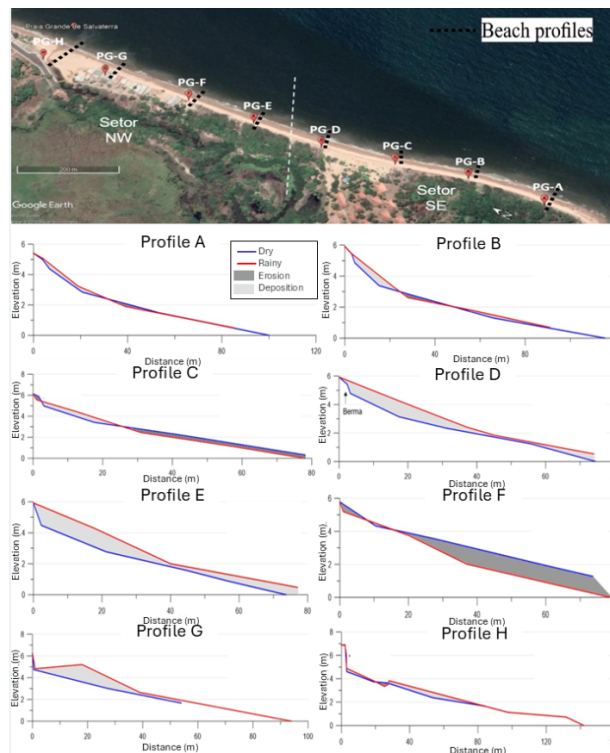
Figure 9. Beach profiles of Praia Grande, adapted from Souza and Ranieri (2023). Photographs taken on 9/13/2019 (dry season) and 2/11/2020 (rainy season)

Despite the negative values in C and F, the sediment volume variation in Praia Grande was positive in both sectors during the transition from the dry to the rainy period, indicating an accretion trend, mainly in the southeast sector (Figure 9, Table 5).
