MODERN ARCHITECTURE: THE
FAÇADES OF COPAN BUILDING

Pós, Rev. Programa Pós-Grad. Arquit. Urban. FAUUSP. São Paulo, v. 27, n. 50, e162808, 2020.

A CONSERVAÇÃO DA ARQUITETURA MODERNA: AS FACHADAS DO EDIFÍCIO COPAN

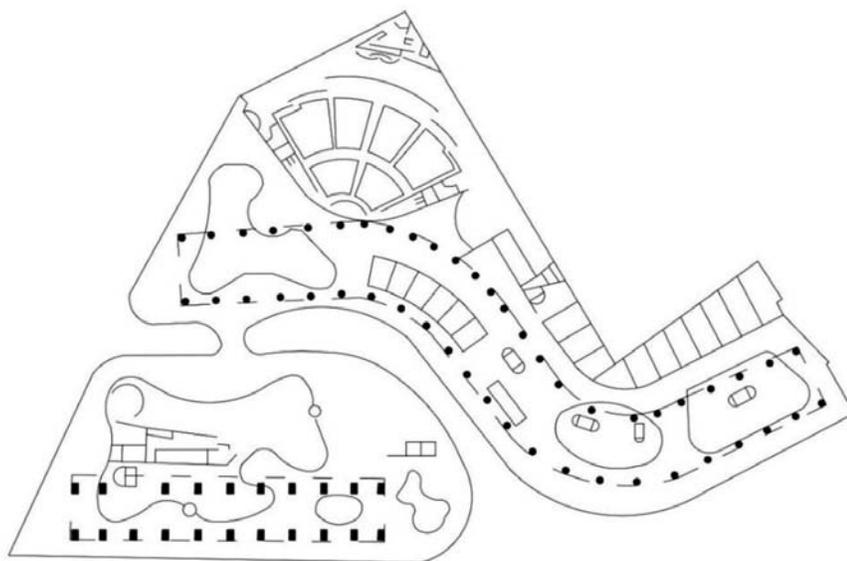
Figure 1 – Floor plan of the Hotel and Residential building
Source: São Paulo City Hall Archive (1952), plan redesigned by Daniella Freitas do Valle.

The complex would also include a cinema for 3,500 people, a 500-seat theater, bars, restaurants, a swimming pool to serve both guests and residents, a commercial gallery on the ground floor with shops, and a floor called a "terrace" (see Figure 1) - which consisted of an architectural solution taking what normally happened on the ground floor to a higher level, the open ground floor of Modern

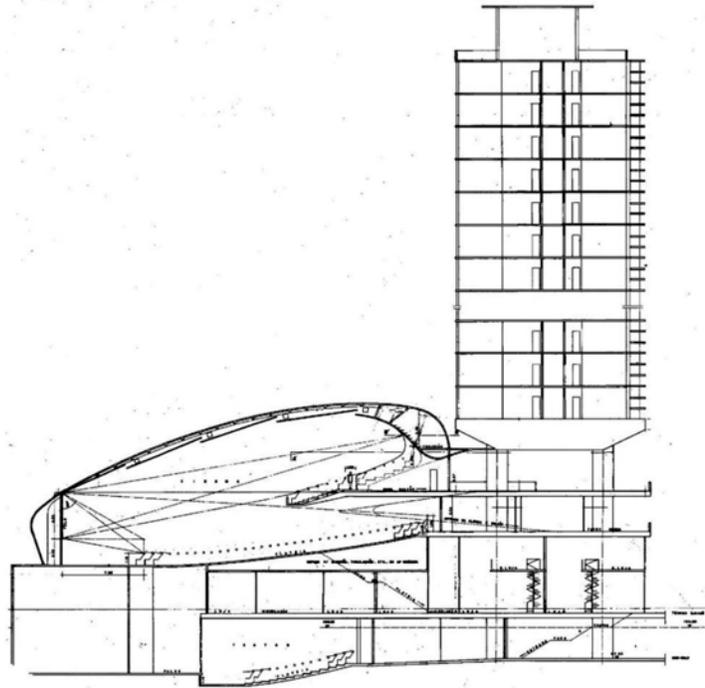
Figure 3 – Cross-section of the Copan building
Source: São Paulo Municipal Archive.

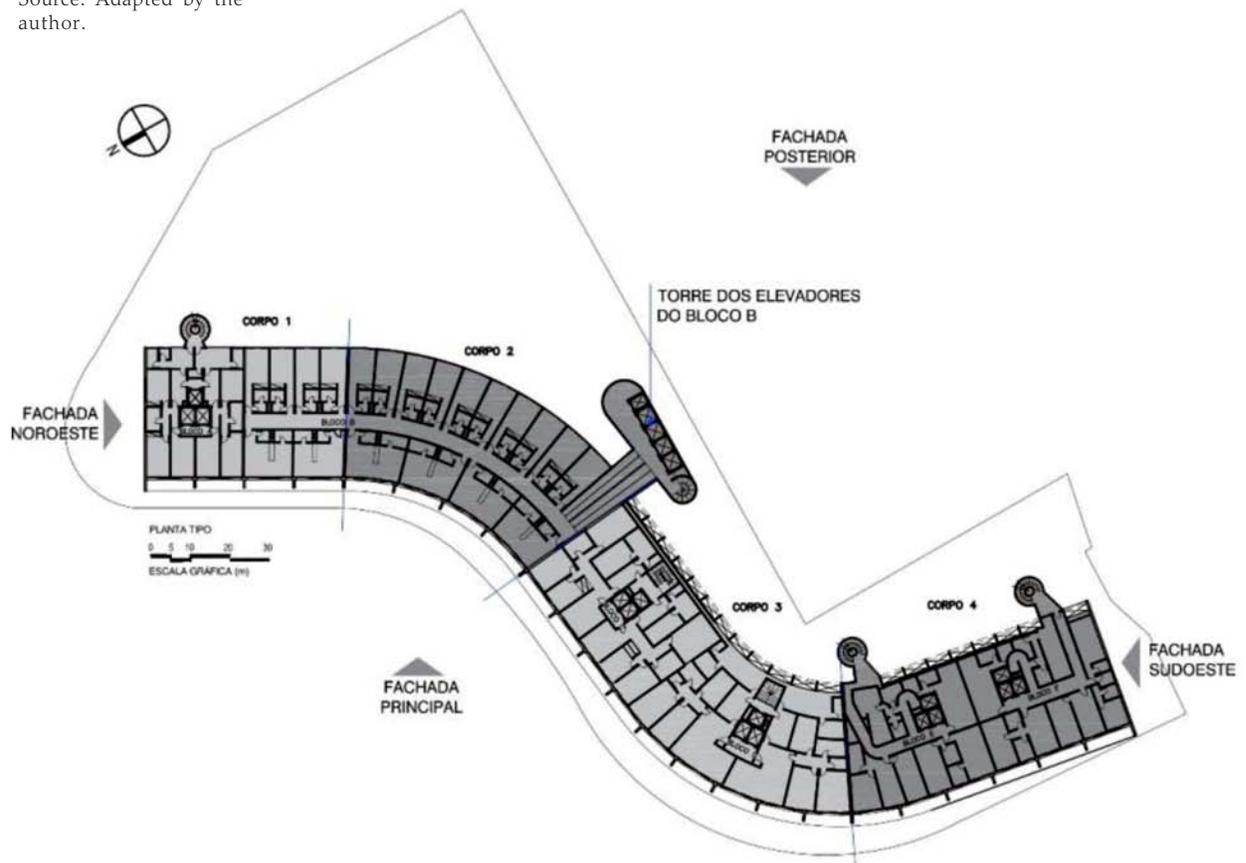
Figure 4 – Floor plan
Source: Adapted by the author.

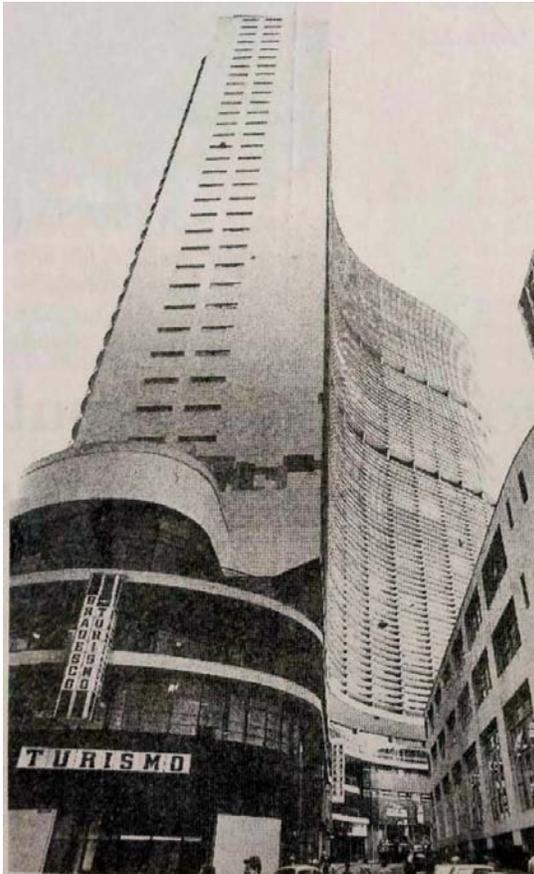
Figure 6 – Degradation of the façade published in 1991 by the newspaper *Folha de S.Paulo*
Source: Copan Archive.

Everything at the Copan is on a grand scale, even its problems, and the façades are no exception. For decades, its façades have suffered from degradation due to lack of maintenance and the natural wear and tear of its elements and components. A photograph published in a 1991 report shows the extensive area of shedding on the northwest façade of the building (Figure 6).

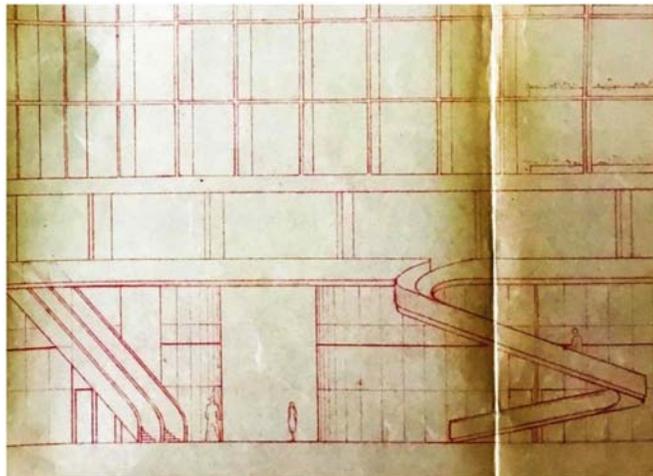
Figure 7 – Partial view of the Front Façade with the ramp without pillars
Source: São Paulo City Hall Archive.

In the São Paulo Municipal Archive, 4 distinct phases of the city hall designs were found, three of which are in the process that was approved and constructed and the first, which dates from May 1952, appears in a different process, together with the hotel. In this design, Copan appears without its famous brise-soleil and with a winding ramp unsupported by pillars (Figure 7).

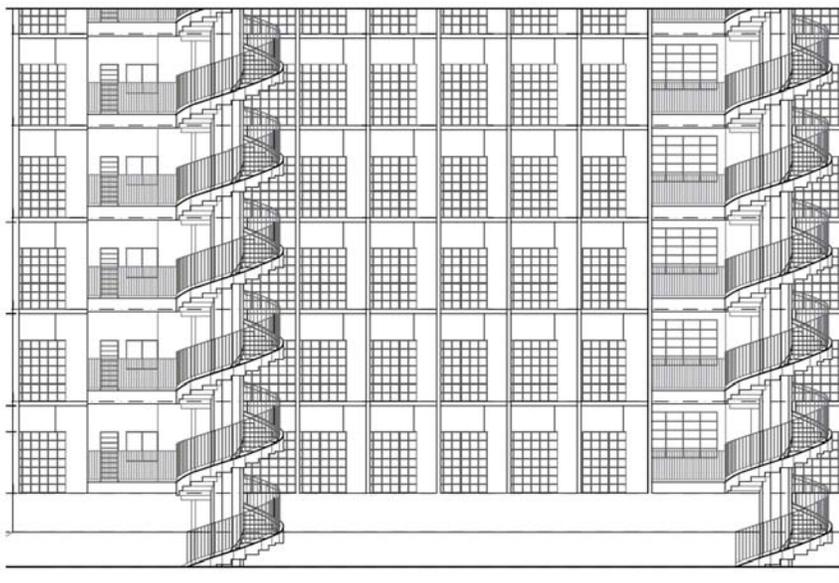
Figure 8 – Partial As built of the Rear façade (Blocks F and E)
Source: Prepared by the author.

The analysis of the graphic pieces enabled the information from the architectural projects to be compared with that on the structure. Through an extensive survey carried out on site, measuring architectural and structural elements, the as built was prepared, which made it possible to cross reference the information on what was built with the original designs and, with this, it was concluded that the structure design was based on the design approved by the city, but that the changes made during construction were not made compatible by the architecture (Figure 8).

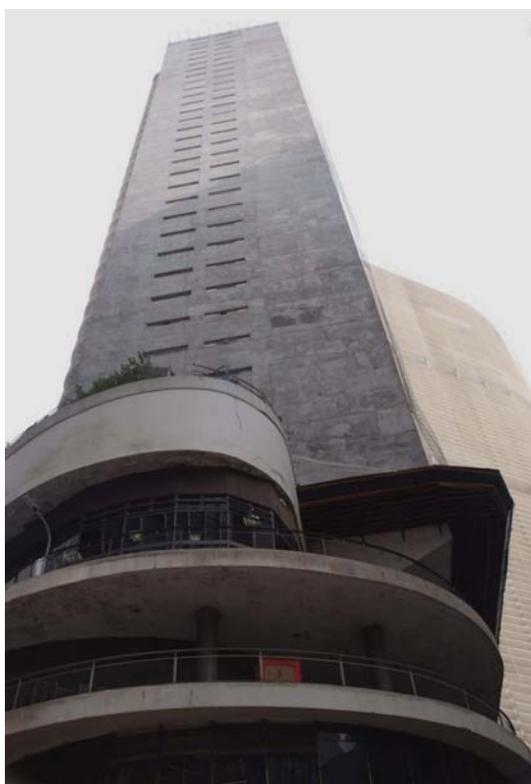
Figure 9 – Partial view of the Northwest and Main Façade with the protection screen
Source: Authors collection.

Following the restoration of the Copan Building façades (Figure 9), conservation policies will have to be adopted based on systematizing preventive maintenance actions, in order to delay deterioration and the need for major, costly restoration interventions (BONFIM, 2019) .
