## HISTORIC HOUSE MUSEUMS AND THEIR CHANGE OF USE: SEARCHING FOR BALANCED BUILDING PERFORMANCE: A CASE STUDY IN SÃO PAULO, BRAZIL

A house museum has its own particularities, presenting many challenges in terms of conservation of the building itself and its surroundings. This article aims to present integrative methods that can be adopted by museum managers and teams to monitor the building performance of a historic house museum. An exploratory study was carried out using Post-Occupancy Evaluation (POE), a multi-methods non-invasive application, at the Ema Klabin historic house museum in São Paulo, Brazil. This approach analyses qualitative and quantitative aspects of the environments to evaluate their performance and the context in which they operate, including the point of view aired by researchers/evaluators, other experts, and regular users. Summary charts and maps regarding diagnosis and recommendations were developed to demonstrate the results achieved with these methods. They are the result of cross-sectional surveys, providing input to aid decision making and developing possible guidelines for future projects with similar characteristics.

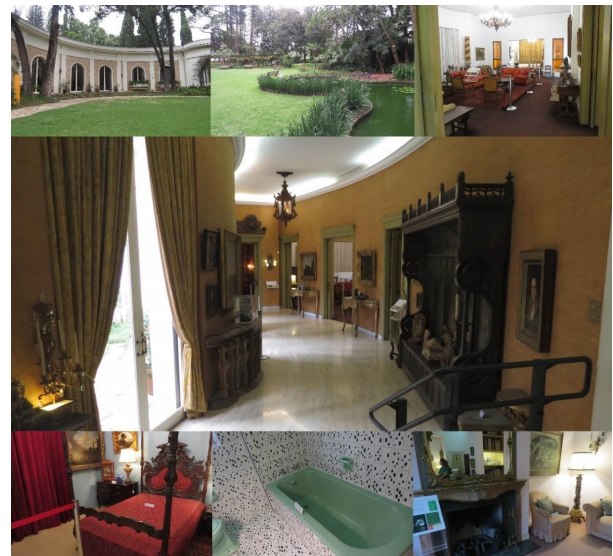
Figure 2: The semicircle gallery. Note all different environments of the house that are accessible through the gallery.  
Source: Cansado (2021).

The form the house acquired in the final design consisted of distributing the rooms around 'a large semicircle gallery' (COSTA, 2017), shown in Figure 2 below, connecting the different environments of the building.

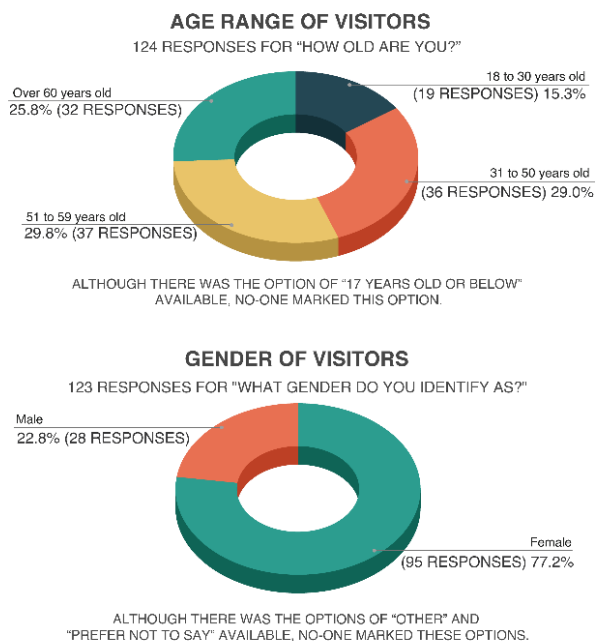
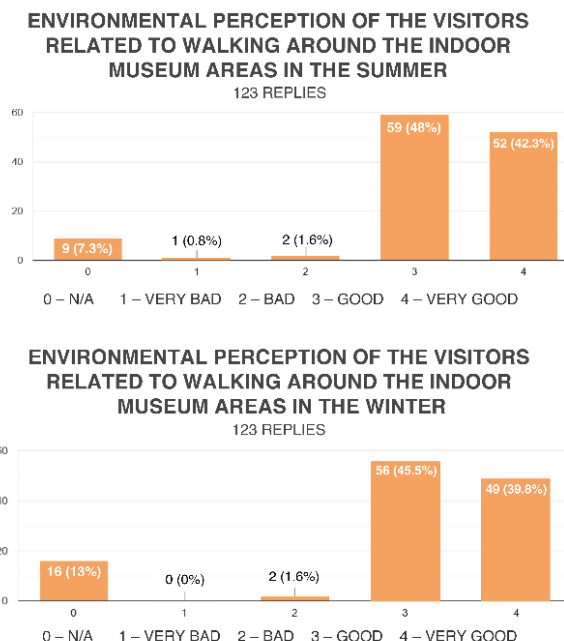
Figure 5: Example of results obtained through the online questionnaire. Source: elaborated by the authors.

The results show that older participants and women have a greater interest in the museum. This can be seen in Figure 5, which shows that most respondents are in the 51- to 59-year-old age group and 77.2 per cent are women. An aspect that may cause some bias concerning the results is whether the respondents reached by FEK social media and newsletters are effectively representative of the museum's public.

The charts illustrate (Figure 5) that visitors consider the house to be thermally comfortable during both the warmest and coldest season of the year. This is justifiable, at first, because the building construction system consists of double perimeter masonry and a ceiling that varies from 3 m to 4.9 m high, and the historic house museum's location, in the Southern Cone, in a subtropical region, with moderate climatic conditions (SON et al., 2016).

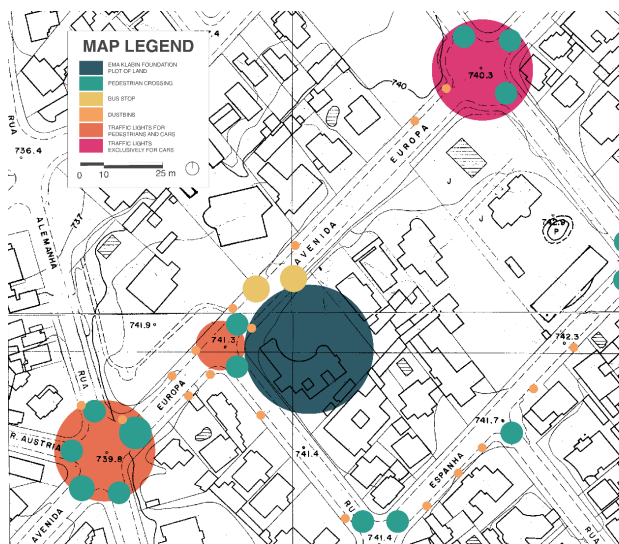
Figure 6: 'as-built' information on the urban surroundings.  
Source: Cansado (2021), adapted from *Seção Técnica de Geoinformação e Produção de Bases Digitais – CESAD – Faculdade de Arquitetura e Urbanismo da USP*.

In order to apply the external urban checklist, the researchers walked around the block where the institution is located, identifying some important points, especially regarding the accessibility criteria as in public transportation availability and adequate sidewalks, as illustrated in Figure 6 below.

The sidewalks were carefully studied and compared to the technical standards, concerning their width, the existence of barriers, positioning of trees, mapping of parking spaces, crosswalks, and traffic lights.

The external checklist revealed that the sidewalks have appropriated width, however, there are also a significant number of obstacles that compromises the urban surroundings' walking accessibility and safety. Lampposts, tree trunks and signalization were the most observed obstacles, furthermore, most pedestrian crossings do not have curb ramps.

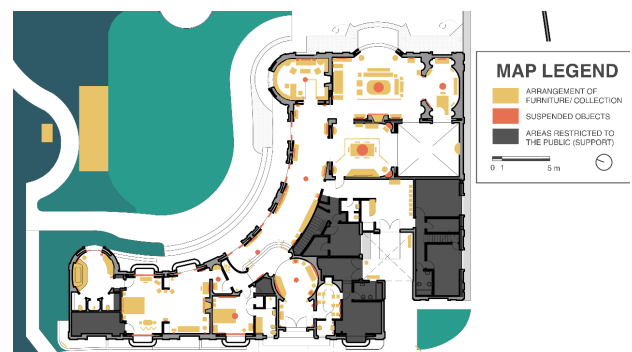
Figure 7: 'As built' of FEK.  
Source: Cansado (2021), adapted from arte3.

Regarding the study of the museum's internal environments, the 'as-built' floor plans were developed, signalling the arrangement of the furniture, the fixtures of electric power, suspended objects, and any potential barriers in circulating areas (Figure 7). This checklist also focused on accessibility, but included fire safety and building performance, which comprises the construction system and the environmental adequacy.

Through the Internal checklist the researchers were able to map the most critical aspects regarding the building's performance. Rainwater infiltration was responsible for the most damage in the structure, being obser-

ved in multiple environments within the building. The climate condition in this part of the Southern Cone is characterized by heavy rain during the summer period, which, coupled with the numerous trees surrounding the house (whose leaves frequently clog the installed gutters), means that the rainwater is not properly drained.
